Manhole Inspection Summary

Manhole # S29AA1005MH

Insp Date: **9/29/08 3:10 PM**

Location Address: **BEECH AVE**

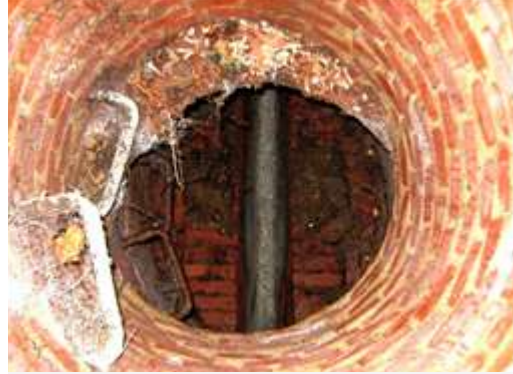
Top View

Bench ☒ Exists Material: **Brick** ☐ Parged ☒ **Debris** (not Condition related)

Steps Count: **5** Missing: **0** ☒ **Corroded**

Surcharge ☒ **Evidence Of Surcharge** Depth: **3** (ft.) ☐ Active Surcharge Present

Corroded steps. Evidence of surcharge - Bench debris.

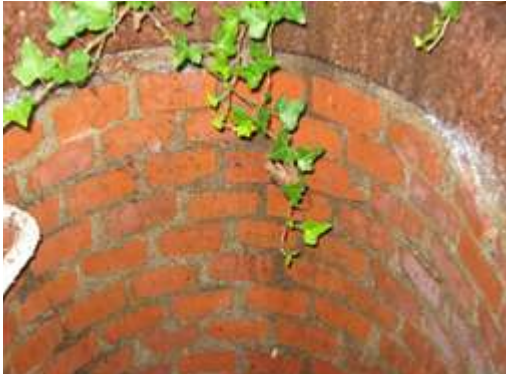
Defect

Infiltration: ☐ None ☒ **Joint** ☐ Cracks ☐ Mortar ☐ Roots ☐ Wall

Adjustment infiltration.

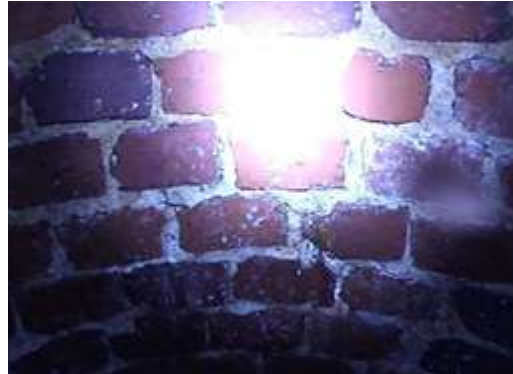
Defect

Condition: ☐ Sound ☐ Cracked ☒ **Root Intrusion** ☐ Loose Brick ☐ Deteriorated

Infiltration: ☐ None ☐ Joint ☐ Cracks ☒ **Mortar** ☒ **Roots** ☒ **Wall**

Barrel root intrusion and infiltration.

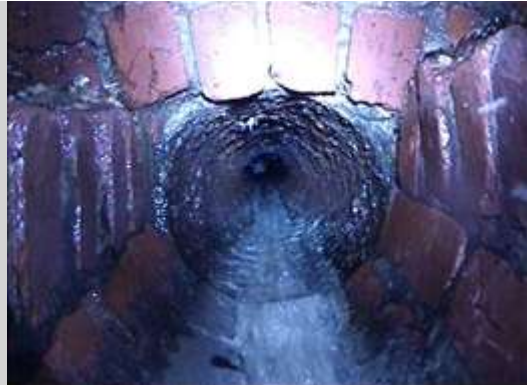
8 in. Circular Gravity Sewer Pipe Out @ 12 O'Clock

Deposits: ☐ None ☐ Mud ☐ Sludge ☐ Debris ☒ **Grease**

Infiltration: **Evidence** Pipe Seal Cond: **Unknown**

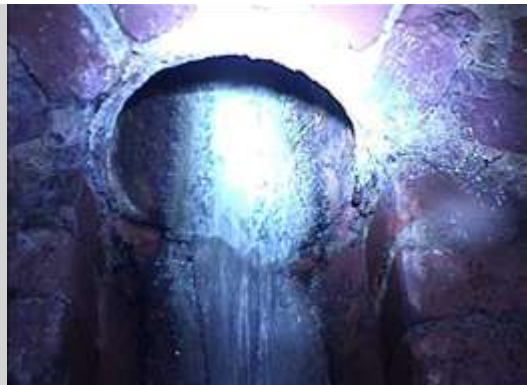
8 in. Circular Gravity Sewer Pipe In @ 6 O'Clock

Deposits: ☐ None ☐ Mud ☐ Sludge ☐ Debris ☒ **Grease**

Infiltration: **Evidence** Pipe Seal Cond: **Roots**
